STRUCTURAL AND COMPOSITIONAL INVESTIGATIONS OF MOSAICO BIZANTINO DECORATION FROM PALACE OF CULTURE, IASSY

Abstract: In this paper we are proposing a complex study about the structure and composition of a sample prelevated from Palace of Culture, Iassy (as fragment detached from the building, without value), in order to identify the existing materials and to select the proper materials useful for restoration. Microscopy allows to observe the presence of the main weathering signs (chromatic alteration, alveolization, blistering, differential disaggregation, efflorescence, decohesion, exfoliation and detachment, cracking, delamination, disaggregation, flaking, loss), EDXRF and ICP-AES allow elemental composition of sample, while GC-MS allow us for the first time in the literature, the identification of the coniferous resin from the glue in mixture with fatty acids, plant oils and possibly beeswax used to bind the paint to the wall support. The composition and aging compounds found in this sample have been analyzed by FTIR and Raman spectroscopy. Also, The CIELAB color parameters were calculated and have been determined clarity (L*), red/green colour component (a*) and yellow/blue col

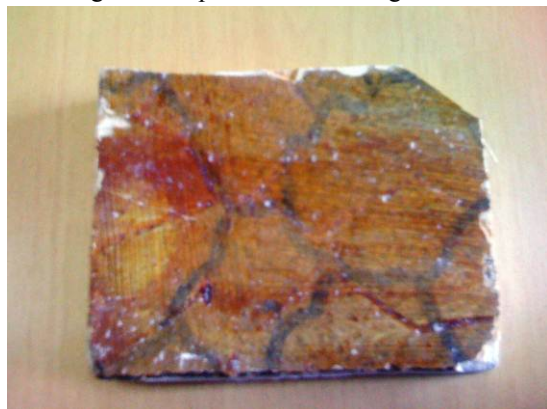
The investigated sample is shown in Fig.1

Fig.1. The photo of Mosaico Bizantino decoration

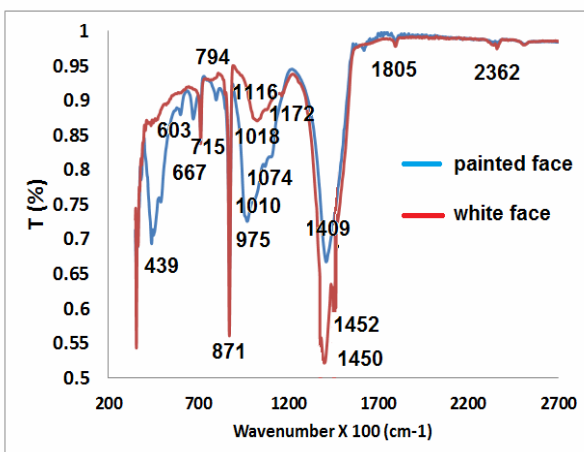
The infrared spectroscopic analysis carried out on the sample prelevated from Palace of Culture allowed the identification of different inorganic phases and organic products, as follows (Fig.2):

- stretching vibrations of calcium carbonate (CaCO_3), peaked at 1962, 1409, 715 and 603 cm^{-1} .
- typical vibrational bands of gypsum ($\text{CaSO}_4 \cdot 2\text{H}_2\text{O}$), centered at 667 cm^{-1} , and its related forms (bassanite and anhydrite, as the main degradation forms of gypsum)
- bands of clay minerals were recognized, through the peaks from 975 cm^{-1} (Si–O–Si bond) from clay, and of calcite (1018 cm^{-1}) [11].
- the bands from 1010 cm^{-1} could be attributed to cellulose/silicate, as a proof for wood pieces and clay in the binder and support [12,13].
- The strong bands at 1409 and 1452 cm^{-1} are characteristic of pigments (ex. Verdigris or red lead);
- the bands below 700 cm^{-1} are assigned to TiO_2 .
- the presence of S is from cadmium/zinc sulphide, used as yellow pigment.

Representative FTIR spectra of the analyzed samples are shown in Fig. 2.

Fig.2. FTIR spectra of painted surface and support surface

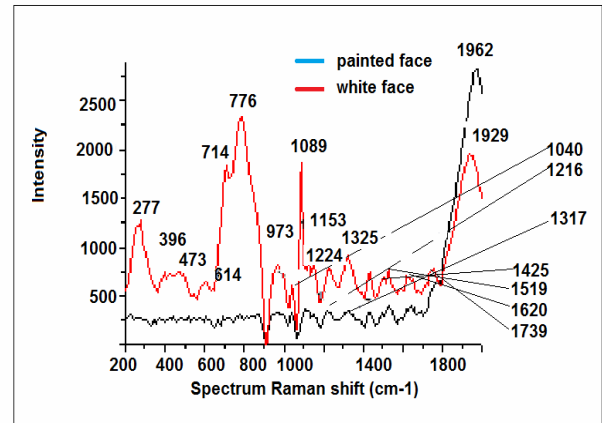
Some of the FTIR bands are not visible in Raman spectra, most probably due to the absorption of different pigments used for painting and due to used binders.

- Raman bands associated with the glyceride carbonyl groups (1739 cm^{-1}), suggest the presence of a drying oil. Also, fatty acid carboxylate bands at 1519 and 1325 cm^{-1} , are identified, those being responsible for the reaction between the copper-containing pigment and the drying oil.

Fig.3. Raman spectra of painted surface and support surface

- Bands at 1409, 1074 and 667 cm^{-1} demonstrate that the lead carbonate is present in the basic or hydrocerussite form, $2\text{PbCO}_3 \cdot \text{Pb}(\text{OH})_2$, element visible from EDXRF investigations, too.

- the Raman bands from 1425 cm^{-1} could be attributed to calcium oxalate, most probably formed by degradation, but majority on the support [14].

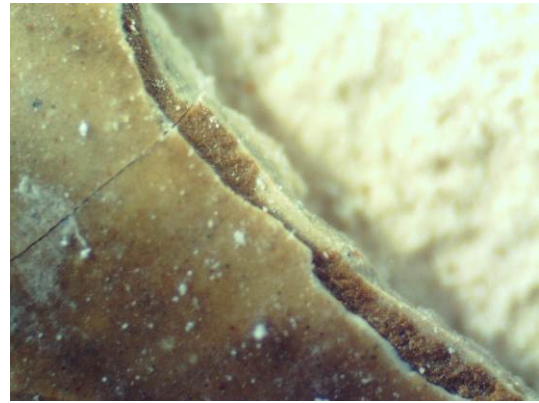
The main problem in this case is the binder (glue) substrate, which is visible in Fig. 5.

Fig.5. The image of all layers from Mosaico Bizantino decoration

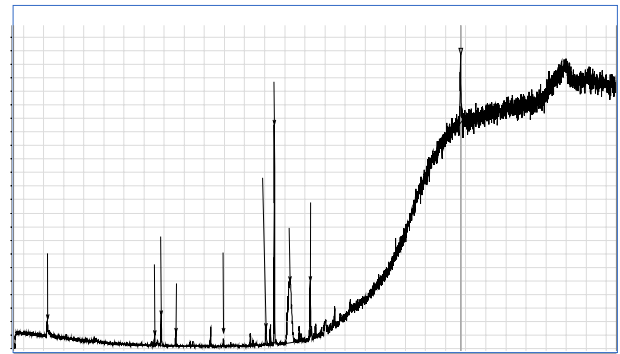
This binder powder prelevated with a spatula, has been extracted in methanol, filtered and after that has been analyzed by GC-MS, Fig.6.

Fig.6. GC-MS results from Mosaico Bizantino decoration

The presence of fatty acids, diacids, hydroxy-acids, long chain alcohols and specific alkane patterns highlighted the presence of beeswax, animal fats, plant oils and pine resin. GC-MS analysis of the binder showed that the medium consisted of oil with addition of natural resin.
