## DEGRADATION OF WOOD DECORATIONS FROM 18<sup>TH</sup> CENTURY OLD HOUSES

**Abstract:** A particular house built in the second half of the century XVIII<sup>th</sup> with a special note in Romanian architecture of this period, has been evaluated in this paper. Now this house is in an advanced damaging situation and needs to be restored urgently. It is an unique architectural house from the south part of Romania region (with wood decoration), and the analysis from this paper had been recorded from detached not useful fragments behind the building, in order to identify the existing materials and to select the proper materials useful for restoration. Microscopy permits one to observe the structure of layers, EDXRF and ICP-AES allow elemental composition of samples and to identify the chemical groups present here. Raman spectrometry method was widely used for investigating the aging of wood from this building. The CIELAB color parameters were calculated and have been determined clarity ( $L^*$ ), red/green colour component ( $a^*$ ) and yellow/blue colour component ( $b^*$ ) and their derived magnitudes: chroma ( $C^*$ ) and tone ( $H^*$ ). The differences between treated and non-tre

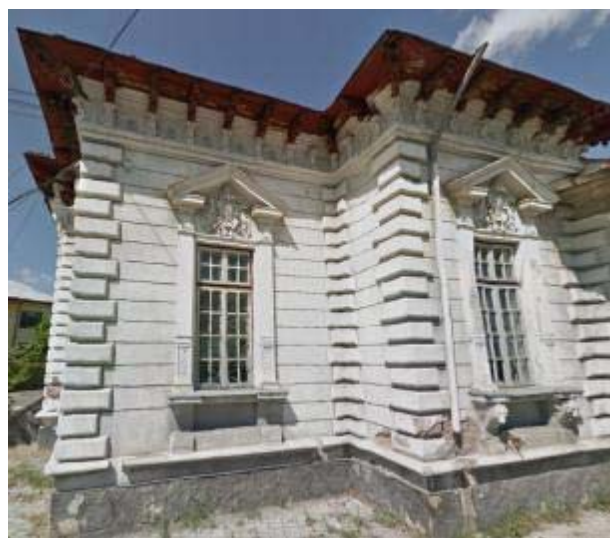
Fig. 1. Cioflea House (XVIII<sup>th</sup> century)

This building is in an advanced state of degradation and deterioration, and all delay of interventions is injurious

to this valuable monument (Fig.1). The main cause for this deteriorations and degradations is the losses of tightness of shingles cover, due to exposure to direct sun light, wind and rains, and cannot provide protection to the weathering. Could be observed a loss of resistance - as the damage progresses, the wood is soaked and fragile. Decayed wood breaks easily perpendicular to the fiber break without being crushed chips. Weight loss - very degraded wood is lighter than healthy wood of the same species, due to the destruction of wood substance by fungi. Changing the color - is often the most obvious sign of degradation. The appearance of brown islands - closed or some lighter may indicate an incipient decay (Fig.2).

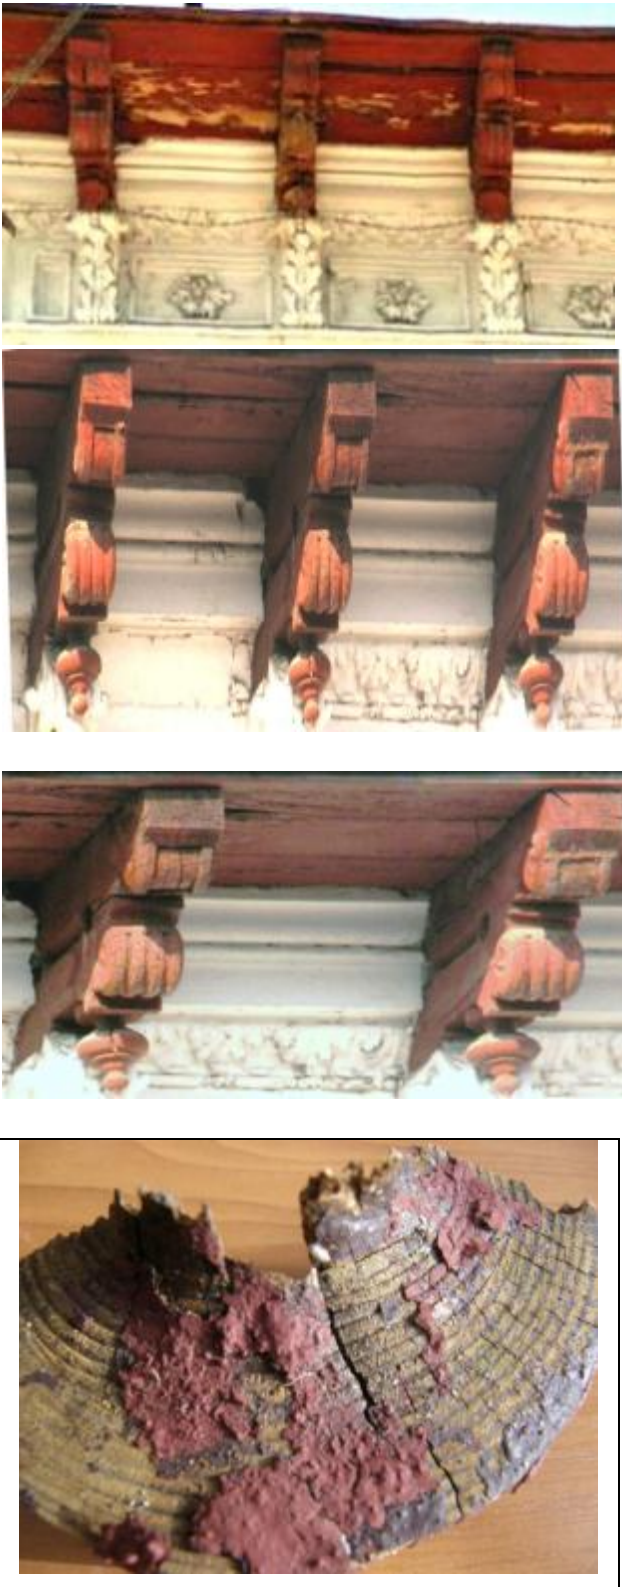
Fig.2. Images of different wood decorations

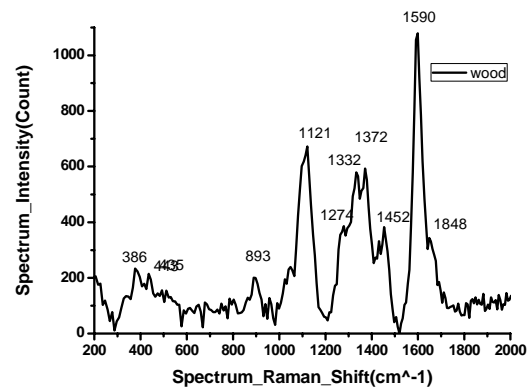
Fig. 3. Raman spectra of the wood

Raman spectra were registered in the region 200-2000  $\text{cm}^{-1}$ . These are shown in Fig. 3. Read lead, different red iron oxide pigments and cadmium red can be identified. In some cases the method can be used alone for pigment identification and in many cases it provides useful additional evidence for pigment identification using other instrumental techniques (optical microscope analysis, XRF).
