NON-DESTRUCTIVE AND MICROANALYTICAL TECHNIQUES FOR COMPOSITION AND STRUCTURE IDENTIFICATION OF THE WALL MATERIALS FROM PALACE OF POTLOGI

Abstract: 45 km from Bucharest there is an example of Brancoveanu architecture, the Palace of Potlogi. Built in 1698, the first royal residence built in the new style. Exterior and interior decorations of the building are the most interesting parts of the palace, including the decorations, sculptures, galleries, portraits, even the garden and courtyard entrance plane, have some oriental influences. Although simple or torso columns, capitals neo-corinthic, fretted railings, doors and windows frames, consoles with original heraldic signs disappeared. Also, some fragments of stucco decoration have been used in abundance with a rare delicacy floral. Even the restoration started some years ago, is almost ready, some analysis have been imposed (from detached not useful fragments behind the building), in order to identify the existing materials and to select the proper materials useful for restoration. Microscopy allows observing the presence of resin; WDXRF allows elemental composition of sample, while FTIR spectrometry method was widely used for inves

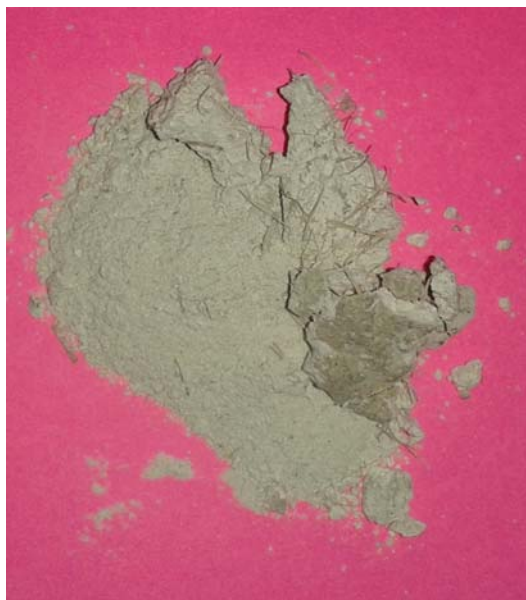
The sample prelevated from the Palace of Potlogi was from detached not useful fragments behind the building, Fig.1.

Fig.1. The analyzed sample

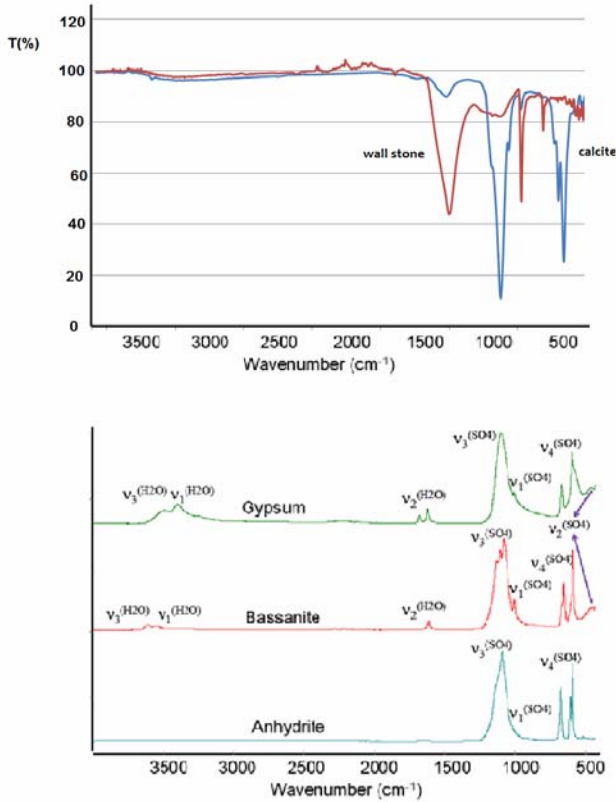
The infrared spectroscopic analysis carried out on the sample prelevated from Potlogi Palace allowed the identification of different inorganic phases and organic products, as follows (Fig.2):

- stretching vibrations of calcium carbonate (CaCO_3), peaked at 1409 , 705 and 611 cm^{-1} .
- typical vibrational bands of gypsum ($\text{CaSO}_4 \cdot 2\text{H}_2\text{O}$), centered at 1109 , 669 and 596 cm^{-1} , and its related forms (bassanite and anhydrite). Common forms of Ca-sulfate are anhydrite CaSO_4 , bassanite $\text{CaSO}_4 \cdot 0.5\text{H}_2\text{O}$ and gypsum $\text{CaSO}_4 \cdot 2\text{H}_2\text{O}$ [9]. Anhydrite typically forms at higher temperatures and gypsum at lower temperatures [10] and transformations between these two forms of Ca-sulfates do not occur readily under dry conditions at low temperatures.

- The characteristic bands of thenardite, centered at 1034 cm^{-1} , were also found, as a first proof for degradation process of the rock.
- stretching vibrations of some organic compounds, most probably from an organic resin (identified by optical microscopy, Fig.3) and from the twine, centred at 944 cm^{-1} (C-O), 1365 cm^{-1} (C-H), 1735 cm^{-1} (C = O).

- bands clay minerals were recognized, through the peaks from 1032 cm^{-1} (Si-O-Si bond) [11].

Fig.2. FTIR spectra of Potlogi stone sample

Finally, in the samples taken from the Potlogi Palace calcite and gypsum (together with related forms – bassanite and anhydrite), organic resin, twine (flax and hemp) were identified. Representative FTIR spectra of the analyzed wall and flax samples are shown in Fig. 3.

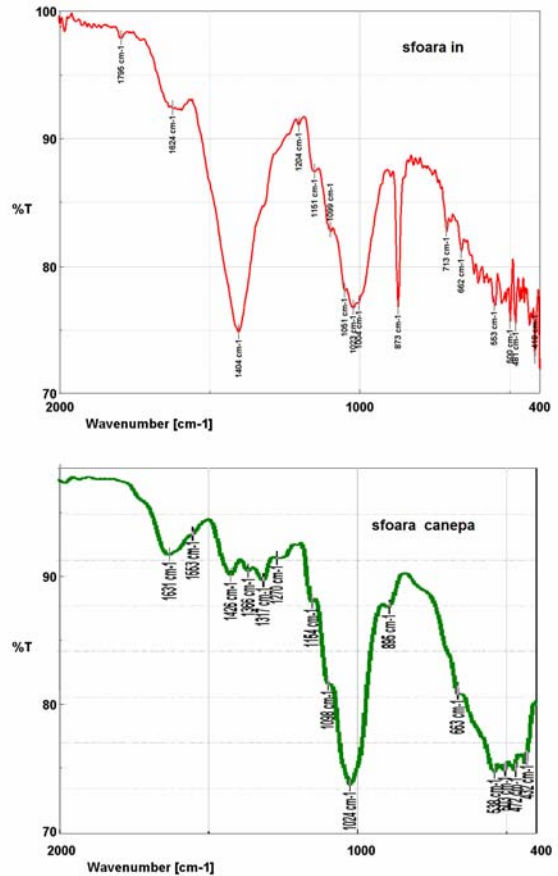
Fig.3. FTIR spectrum of the twine: flax (up) and hemp (down)

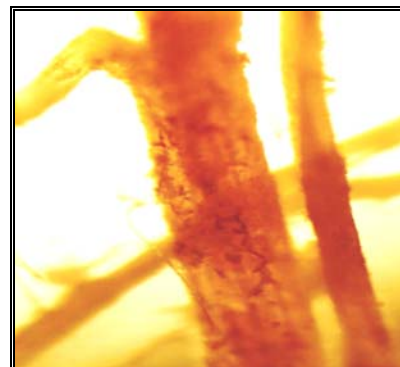
Correlated with FTIR spectra there are EDXRF determinations, Table 1. Also, by optical microscopy was possible to put into evidence the presence of resin (Fig.4) and the presence of flax and hemp fibers (Figs.5, 6).

Fig.5. Fiber present in the wall
